Tachometer in Volvo Amazon

WHEN THE TOP OF THE LINE MODEL 123GT was introduced in the summer of 1966 (model year 1967) it came with a tachometer. This was assigned part number 281046 and was manufactured by Smiths for Volvo. The tachometer is transistorized and features a warning field for excessive engine speeds. Its placement on the dash pad is best illustrated by a picture (see below). The same tachometer was later sold as an accessory to Volvo Amazon, and is included in the 1969 accessories catalogue.

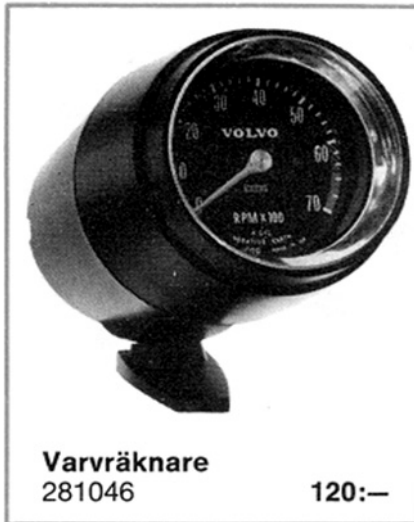
The Smiths tachometer that came factory installed on the 123GT model year 1967 has a chrome ring, red needle and a 10 x 100 RPM scale. This was changed with the model year 1968 and the unit now had a silver ring (non-reflecting), white needle and a 1 x 1000 RPM scale. However, both have the same part number, 281046, and the latter was sold as accessory from 1969. The picture to the left is from the 1969 accessories catalogue and, mistakenly, shows the 1967 tachometer.

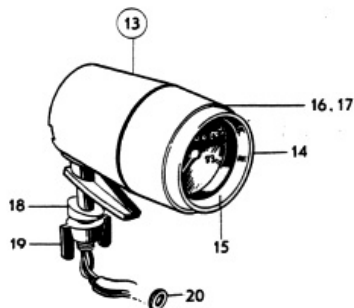
P 130

Sida Page	Grupp Group	INSTRUMENT MED MONTERINGSDETALJER		INSTRUMENT AND INSTALLATION COMPONENTS		Utgåva Issue
Pos. Fig.	Antal Qty		Detalj nr Part No	Benämning	Description	Anmärkning Notes
13	1	.	281046-3	VARVRÄKNARE	REVOLUTION.	SPEC UTF 5314
14	1	.	682963-4	.FRONTKÅPAFRONT HOUSING	
15	1	.		.GLAS.LENS	LAGERFÖRES EJ
16	1	.		.PACKNINGPACKING.	LAGERFÖRES EJ
17	1	.		.RINGRING	LAGERFÖRES EJ
18	1	.	672585-7	.BRICKAWASHER.	
19	1	.	672586-5	.VINGMUTTERBUTTERFLY NUT	
20	1	.	667512-8	GUMMIBUSSNING	RUBBER BUSHING	SPEC UTF 5576
