## Four-way emergency flasher in Volvo Amazon

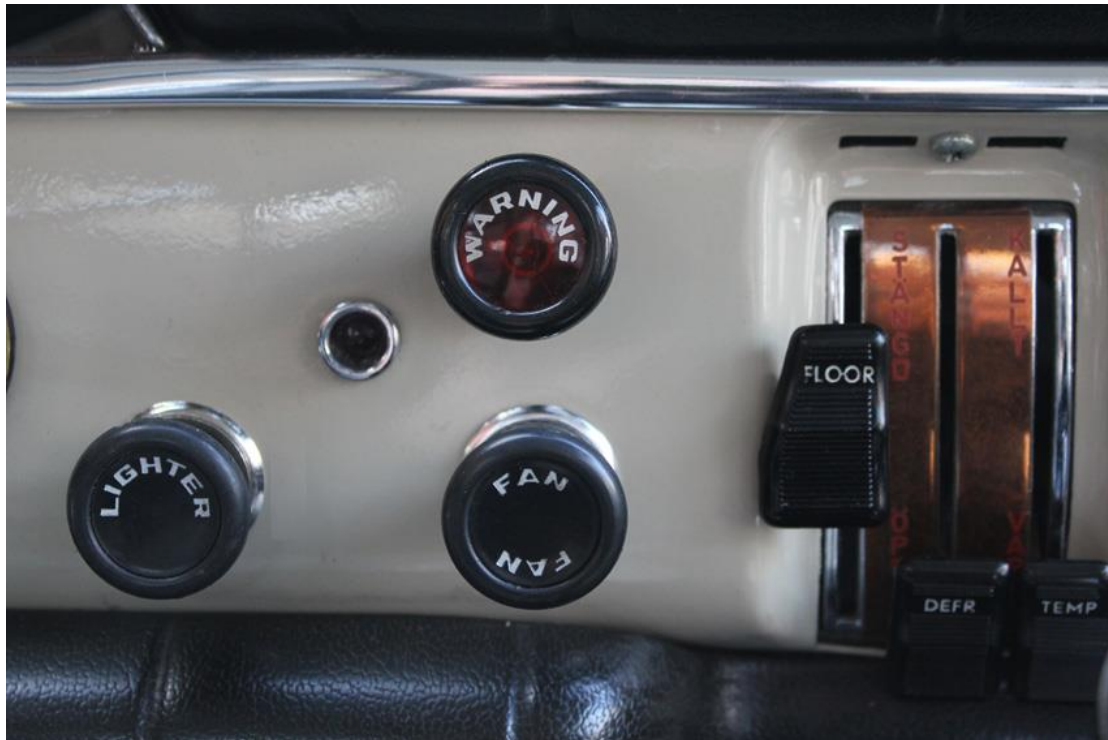
*Emergency flasher unit, 1968 122 s in export edition (part number 673380)*

On Volvo Canadian (both 122 s and 123 GT) the flasher unit was located on the left kick panel, above the hood opener. On Volvo 122 s in export edition the flasher unit was located on the instrument panel, above the fan knob.

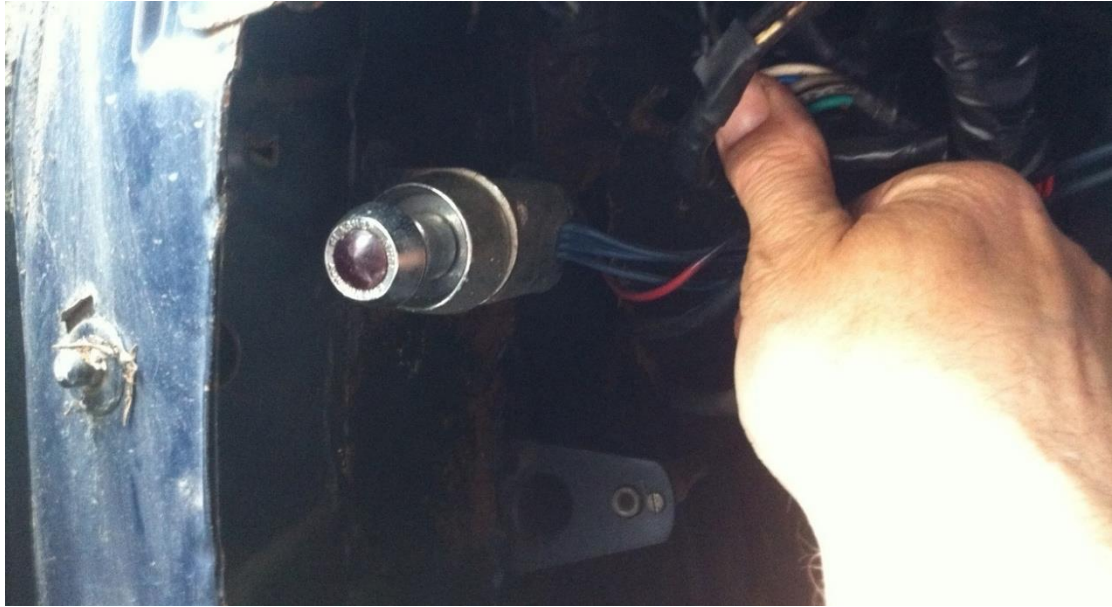
*Emergency flasher unit, 1967 Volvo Canadian GT (part number unknown)*

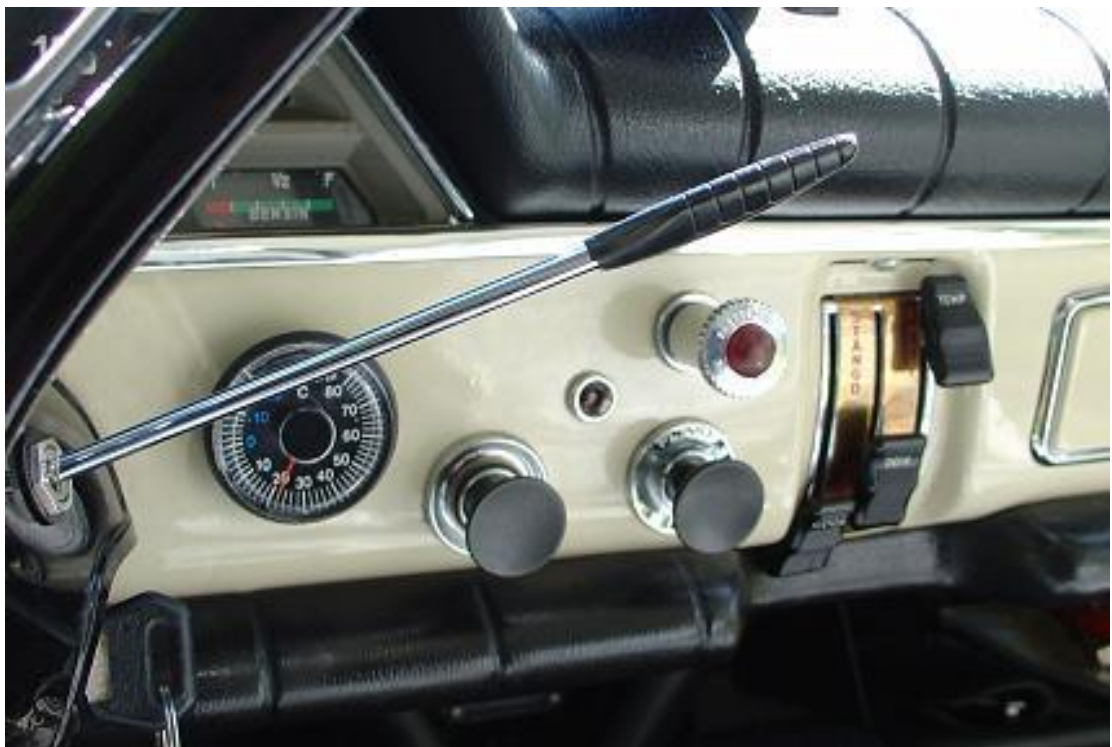
*Emergency flasher unit, accessory (part number 279901)  
The Roberk Co. Model 800*

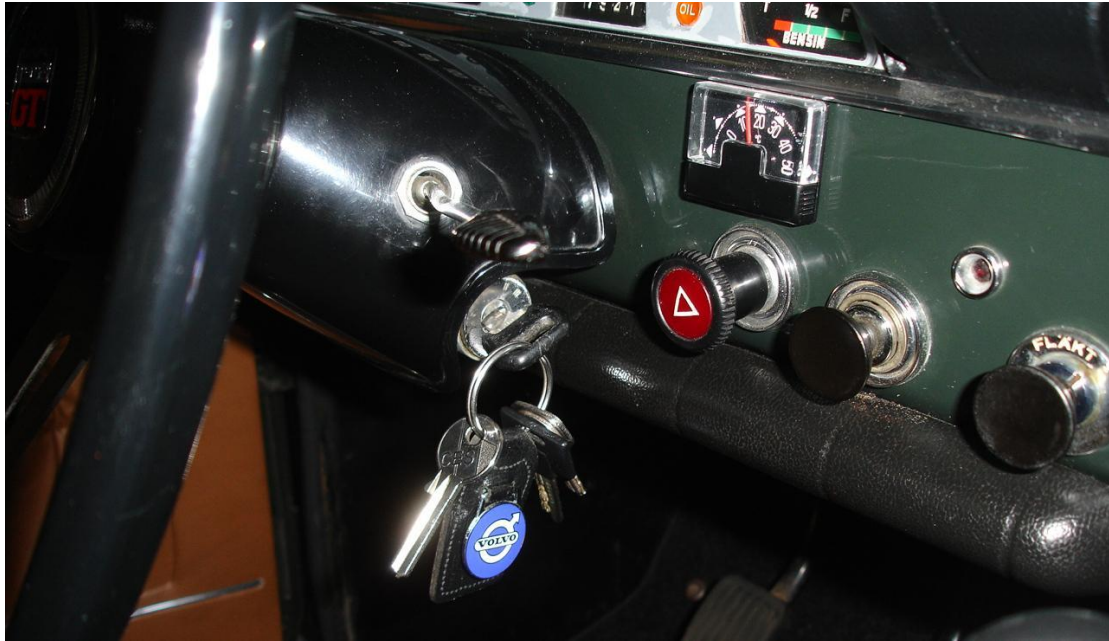
*Emergency flasher unit, 1969 123 GT (part number unknown)*

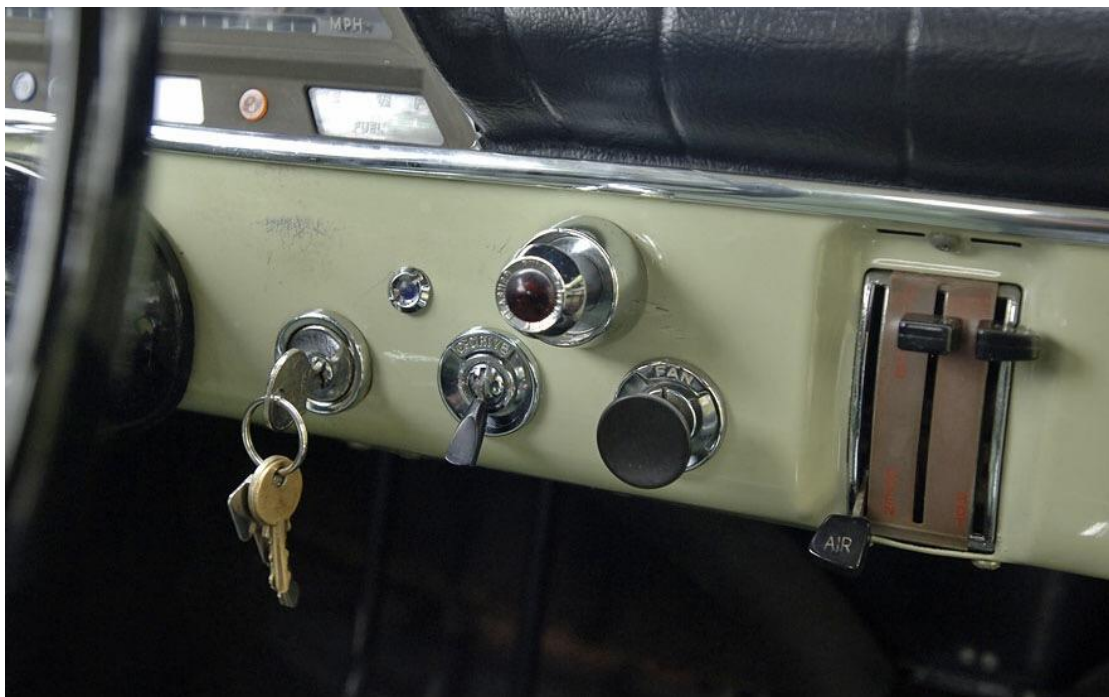
*Emergency flasher unit, 1966 122 s (part number unknown)*

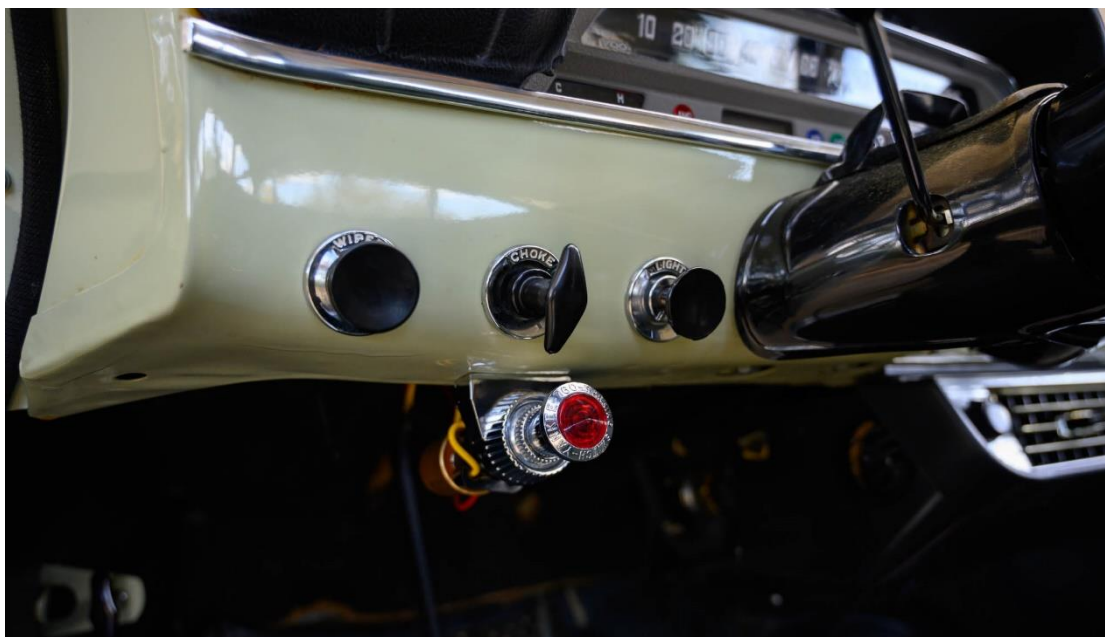
*Emergency flasher unit, 1966 122 s (part number unknown)*

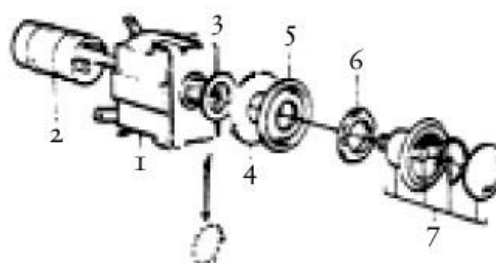
This list is from the spare parts catalogue for the model year 1968 and concerns the flasher unit used in the export cars.

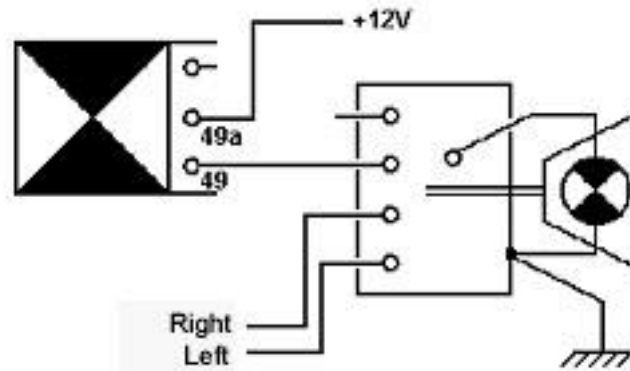
Emergency flasher with separate flasher unit (279901) is connected according to the figure below. The directional indicator switch has position 30 in the wiring diagram and on its right (blue cable) and left (green cable) cables from the switch (673380) are connected. The flasher unit (686452) is connected between plus on the battery and the switch. This way, the unit will work even when the ignition is off. One of the cables from the switch is not used.

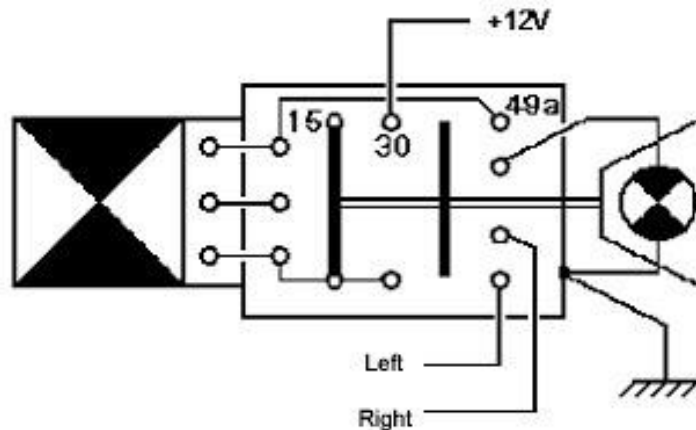
Emergency flasher from an export car or the 140-series (673380) is connected in a similar way. Here, the flasher unit is built in, which makes the entire unit take up less space behind the instrument panel. The principle is the same as above – two cables are connected to the left and right directional indicator and the third to the battery's plus according to the figure below.

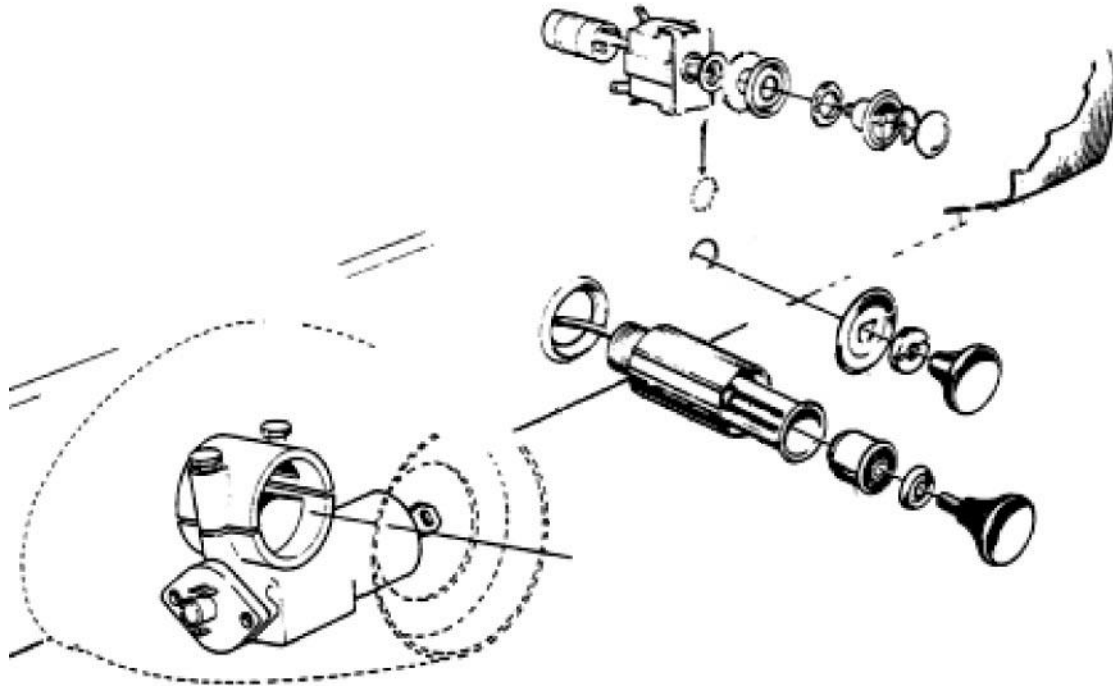
If not, measure and drill a new hole in the instrument panel according to the picture below. The hole should be located 43mm (1.69") above the fan switch. Alternate placement is between the steering wheel and the cigarette lighter, in alignment with this and the fan knob. Be precise! Measure again! Drill.
