Four-way emergency flasher in Volvo Amazon

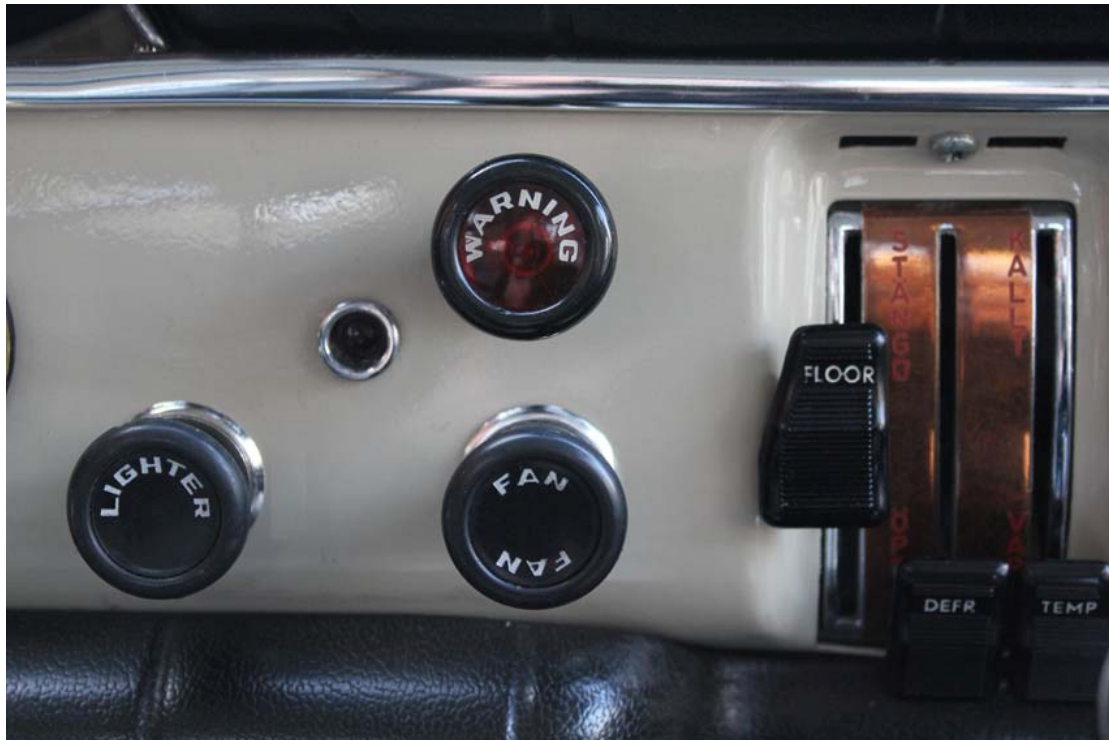
Emergency flasher unit, 1968 122 s in export edition (part number 673380)

On Volvo Canadian (both 122 s and 123 GT) the flasher unit was located on the left kick panel, above the hood opener. On Volvo 122 s in export edition the flasher unit was located on the instrument panel, above the fan knob.

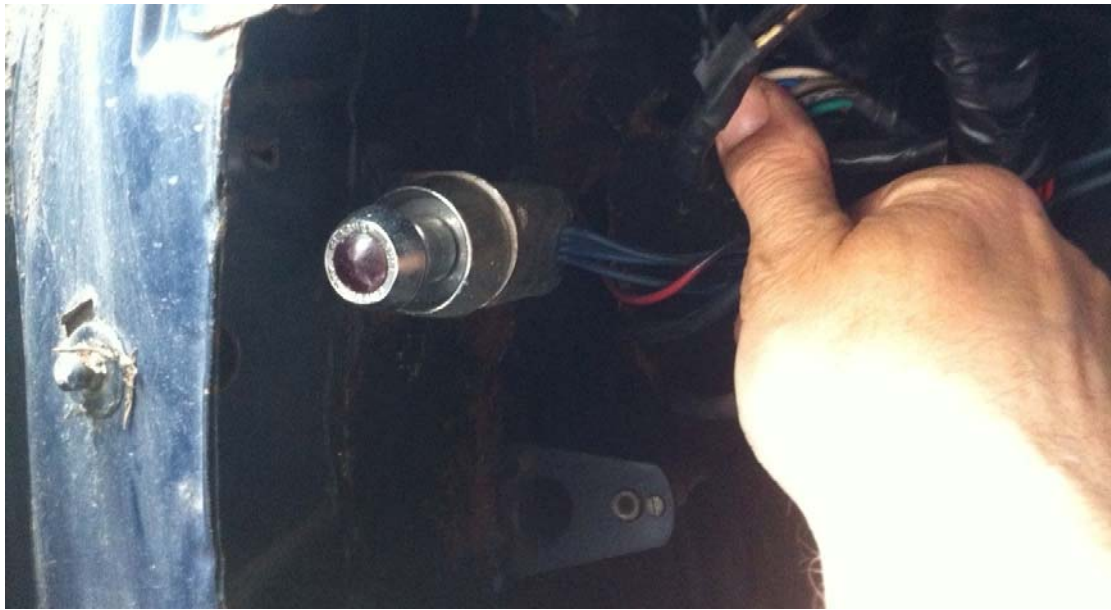
Emergency flasher unit, 1967 Volvo Canadian GT (part number unknown)

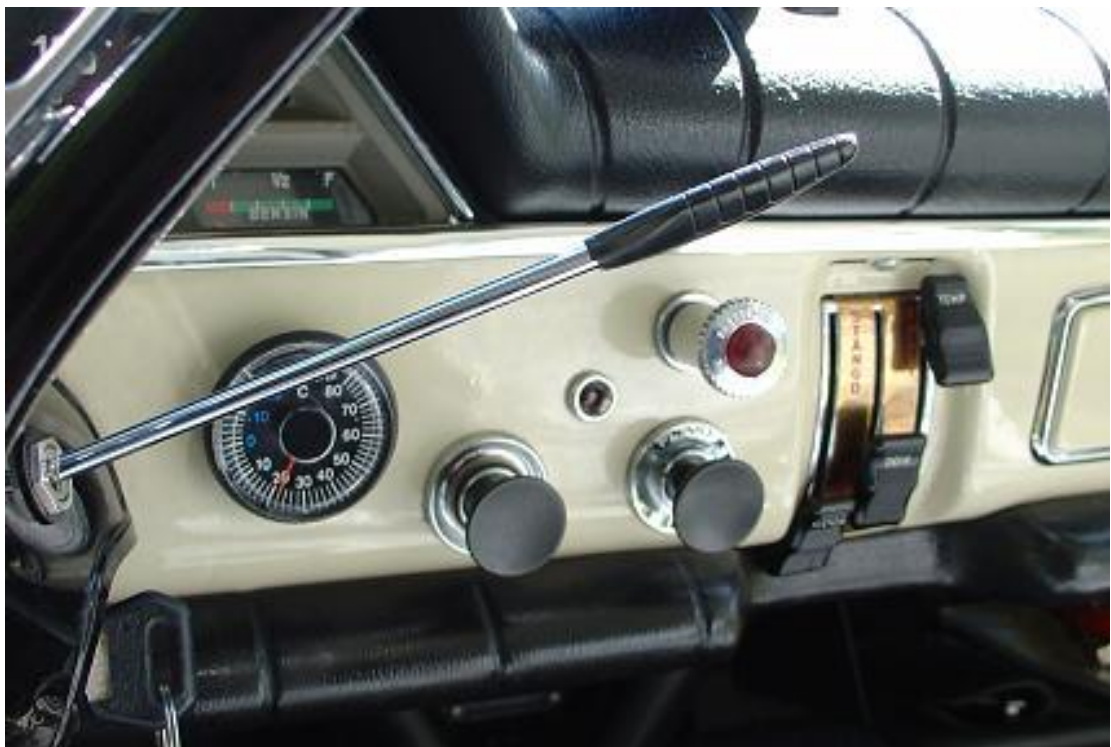
*Emergency flasher unit, accessory (part number 279901)
The Roberk Co. Model 800*

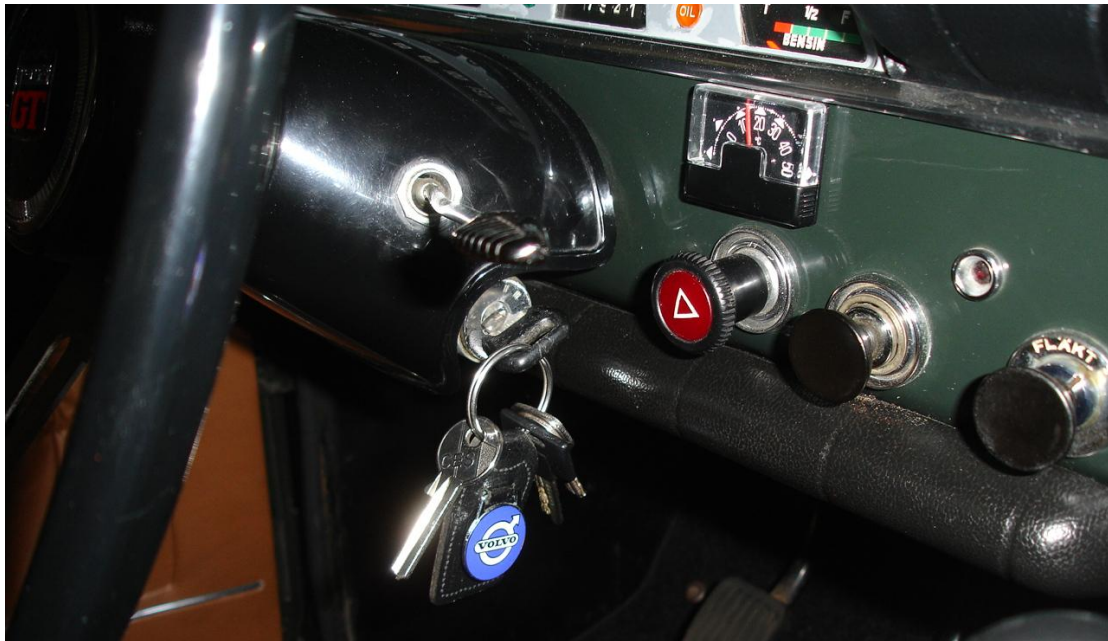
Emergency flasher unit, 1969 123 GT (part number unknown)

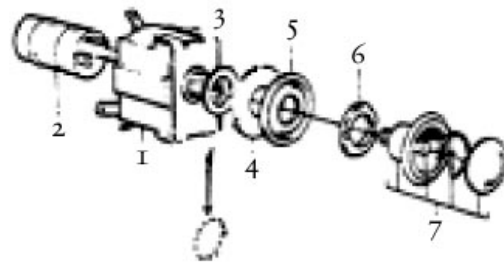
Pos.	Qty.	Part number	Description
1	1	673380-2	Switch
2	1	686452-4	Flasher unit
3	1	673385-1	Washer, aluminum
4	1	673387-7	Washer, insert
5	1	673386-9	Washer, spacer
6	1	673388-5	Nut washer
7	1	673381-0	Button
7	1	277747-2	Bulb

This list is from the spare parts catalogue for the model year 1968 and concerns the flasher unit used in the export cars.

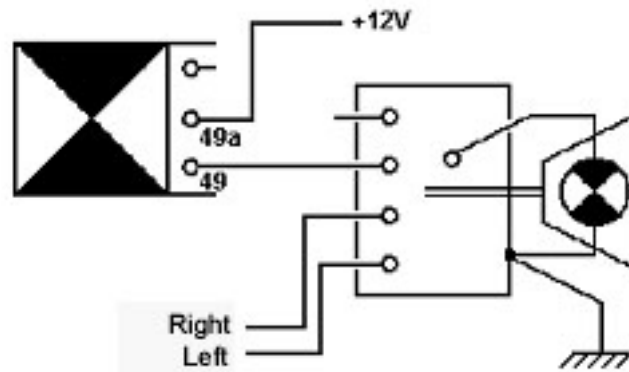
Emergency flasher with separate flasher unit (279901) is connected according to the figure below. The directional indicator switch has position 30 in the wiring diagram and on its right (blue cable) and left (green cable) cables from the switch (673380) are connected. The flasher unit (686452) is connected between plus on the battery and the switch. This way, the unit will work even when the ignition is off. One of the cables from the switch is not used.

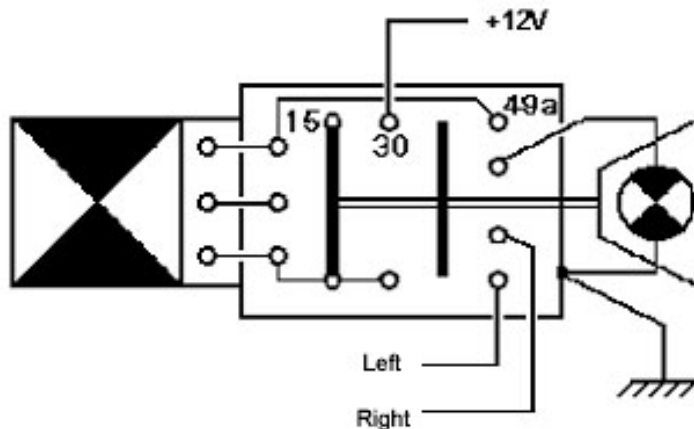
Emergency flasher from an export car or the 140-series (673380) is connected in a similar way. Here, the flasher unit is built in, which makes the entire unit take up less space behind the instrument panel. The principle is the same as above – two cables are connected to the left and right directional indicator and the third to the battery's plus according to the figure below.

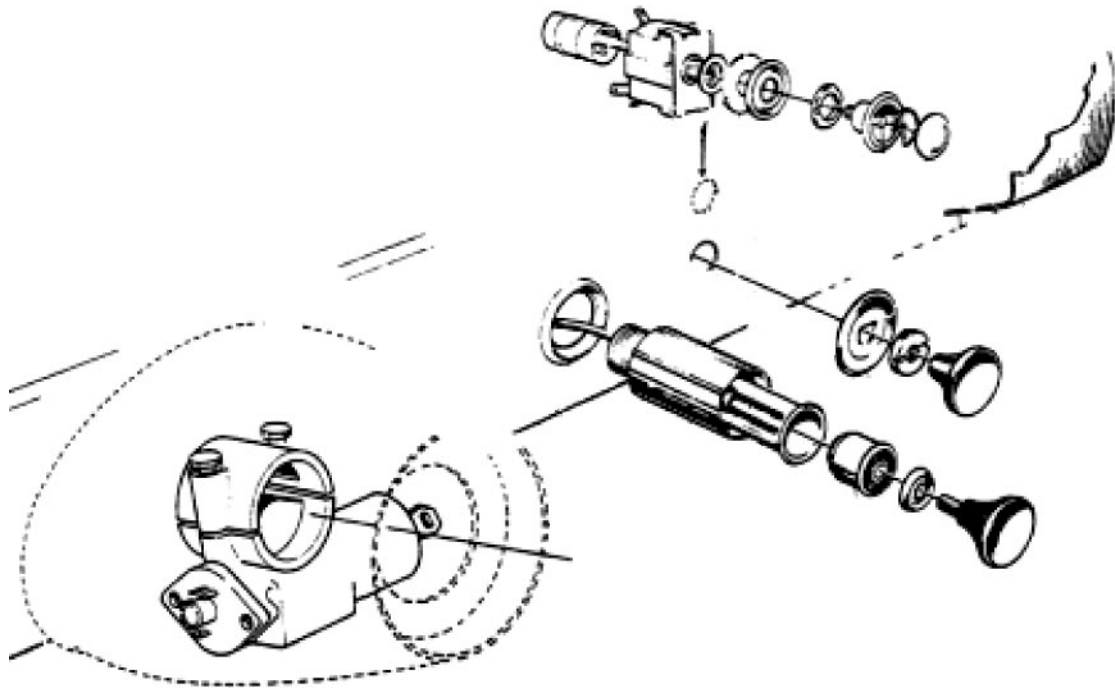
If not, measure and drill a new hole in the instrument panel according to the picture below. The hole should be located directly above the fan switch. Alternate placement is between the steering wheel and the cigarette lighter, in alignment with this and the fan knob. Be precise! Measure again! Drill.

Fit the switch in the instrument panel and secure it with the washers.
